Reference No. 1314470516-025-L-Rev0

COLLIERY DAMS, NANAIMO BC LOWER DAM – DEVELOPMENT OF DESIGN ALTERNATIVES

This letter report summarizes the findings of studies carried out by Golder Associates Ltd. (Golder) for the City of Nanaimo (City) on the Lower Colliery Dam in Nanaimo BC. These studies, carried out principally in May 2015, were primarily related to further development of flood routing remediation options for the Lower Dam. The remediation options that were to be evaluated were drawn from a list of options identified by the Province of BC, which formed part of the basis of an Order for remediation of the Colliery Dams (BC 2015). This letter report documents additional work that has been carried out on two of the options identified in the Province of BC letter, namely, the Overtopping Option, and the Auxiliary Spillway Option. A general arrangement of the Lower Dam, the existing spillway and the proposed auxiliary spillway location are shown on Figure 1.

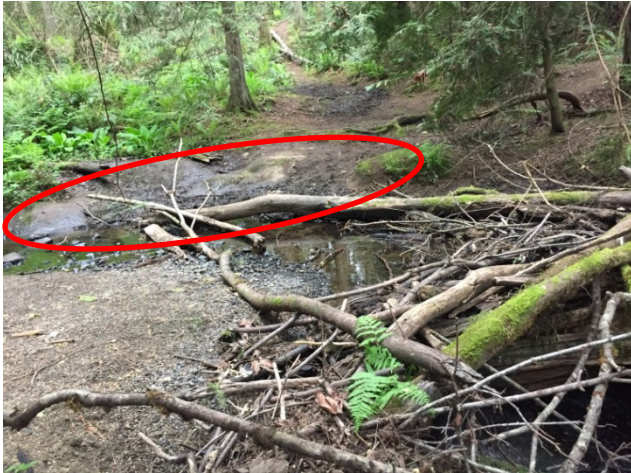
Photograph 3: View of bedrock outcrop looking southwest near proposed auxiliary spillway discharge location into Harewood Creek.

- **Surface information** (nearby rock exposures; see Figure 4 and Photos 3 and 4)—The nearest rock exposures are located to the east and southeast of the proposed spillway, at elevations ranging between 65 to 70 m.

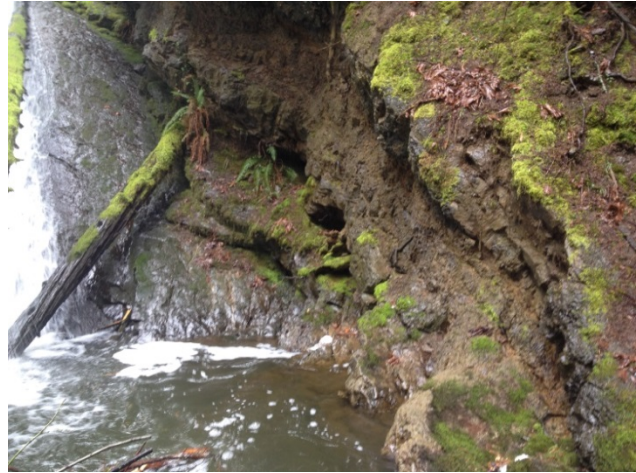
Photograph 4: View of north side of existing spillway chute from discharge pool at base looking upstream.

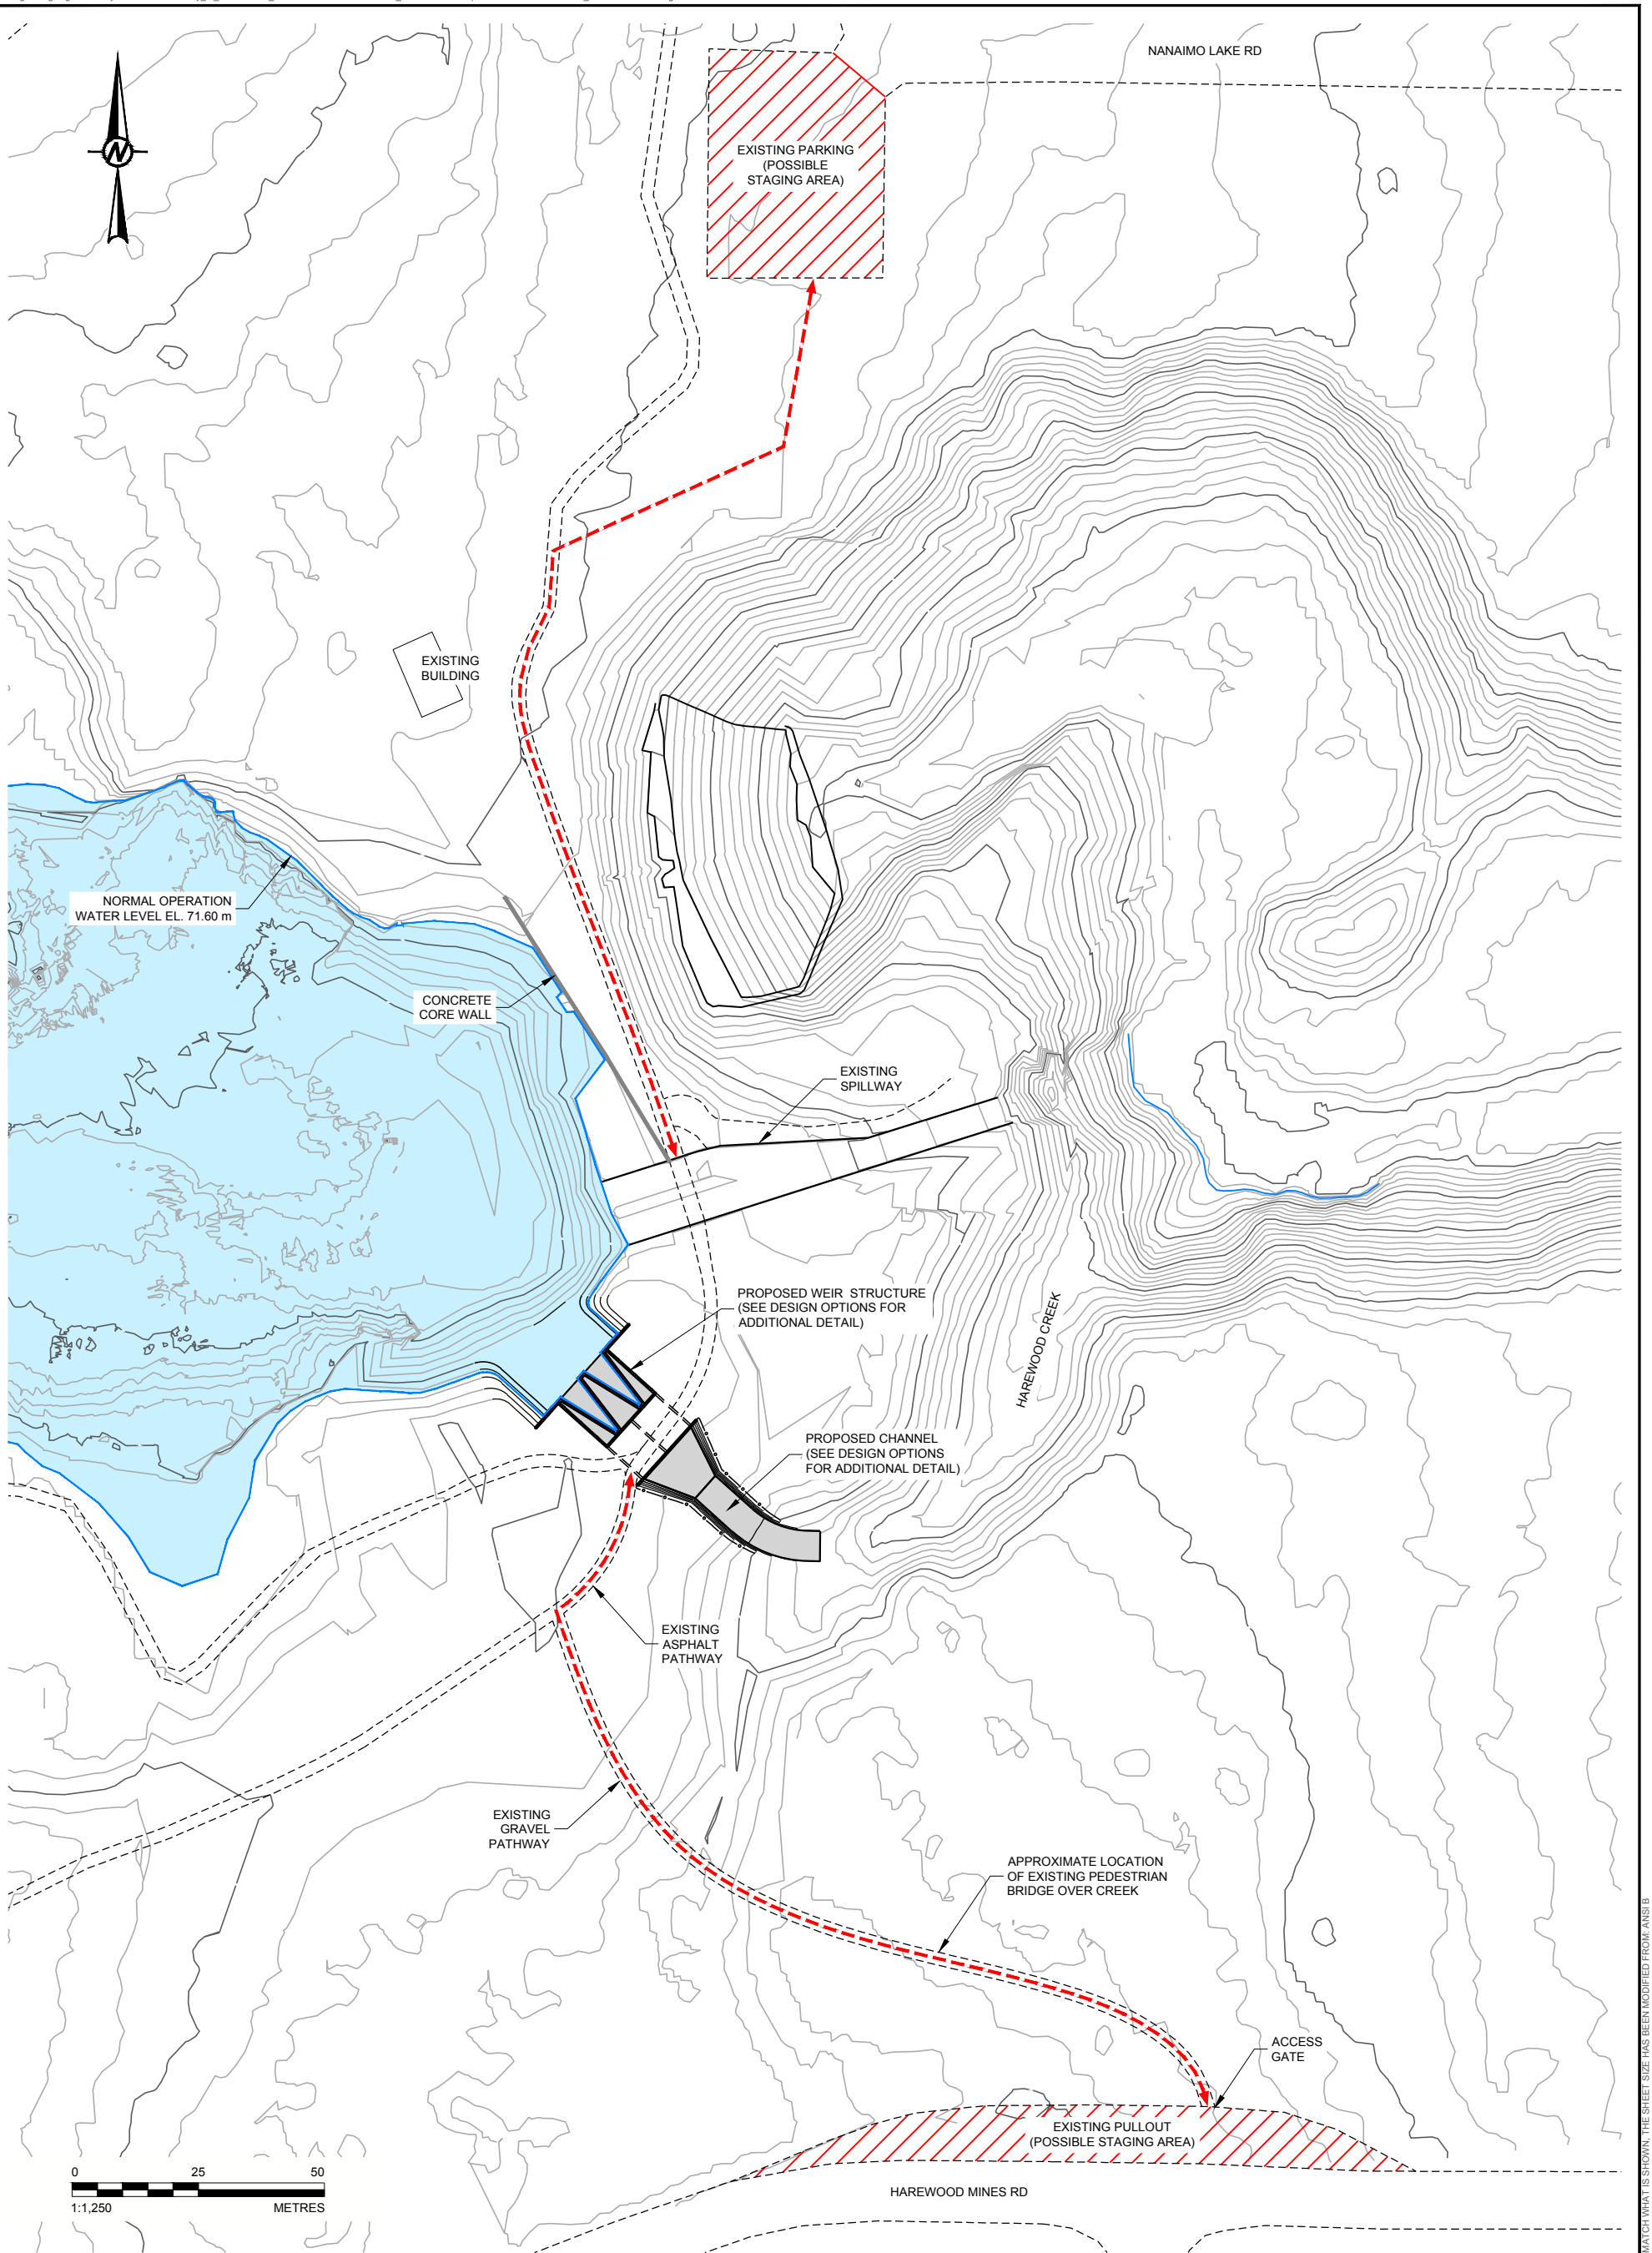
PROJECT No.	PHASE	Rev.	FIGURE
13-1447-0516	2500	A	1

RESERVOIR (AT REGULAR OPERATING LEVEL)
	ACCESS ROUTE
	POSSIBLE STAGING AREA

Access is expected to be from both the north and south sides of the existing spillway (Figure 1). The existing parking lot accessed from Sixth Street is approximately 200 m to the north of the existing spillway along an asphalt path. The Harewood Mines Road to the south of the spillway is accessed via the existing paths. It is anticipated that the bulk of construction materials and equipment can be mobilized via the parking lot to the north, however some limited access may be required via the trail network on the south side of the existing spillway.

Different access routes were considered during the May site visit. Access routes from south of the site were considered to avoid crossing the bridge over the existing spillway. The shortest route with the least impact to the trails and trees is expected to be from Harewood Mines Road via an approximately 200 m long pedestrian trail comprising 170 m of gravel path and 30 m of asphalt path (Figure 1). This will require:

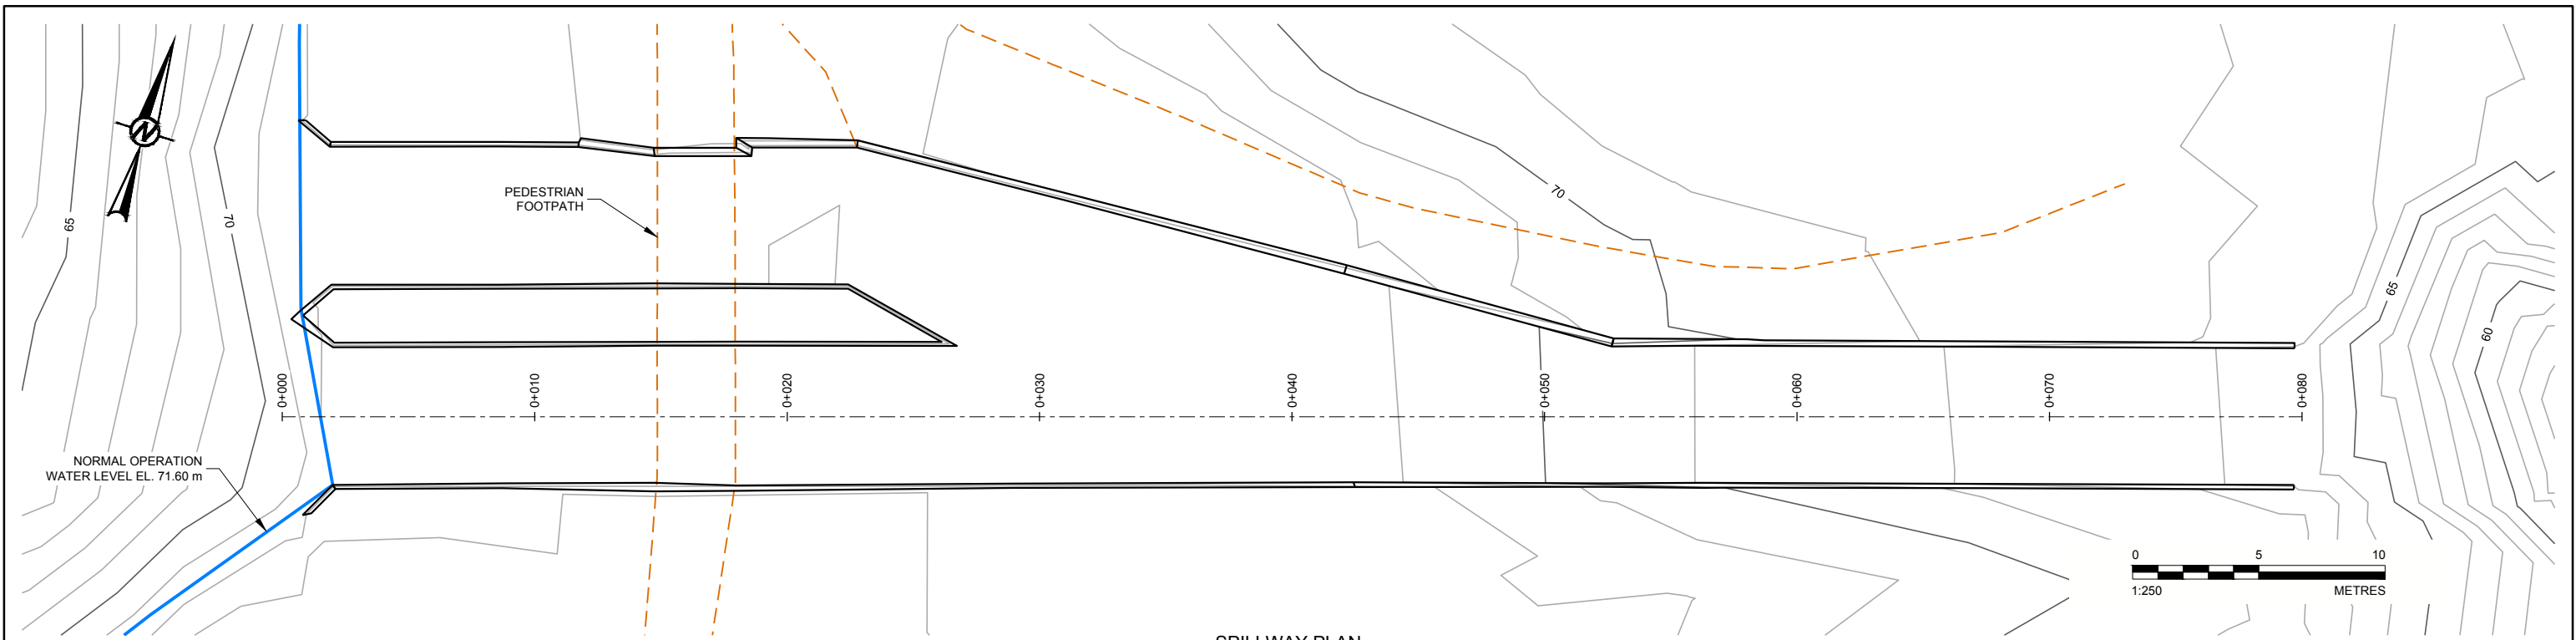
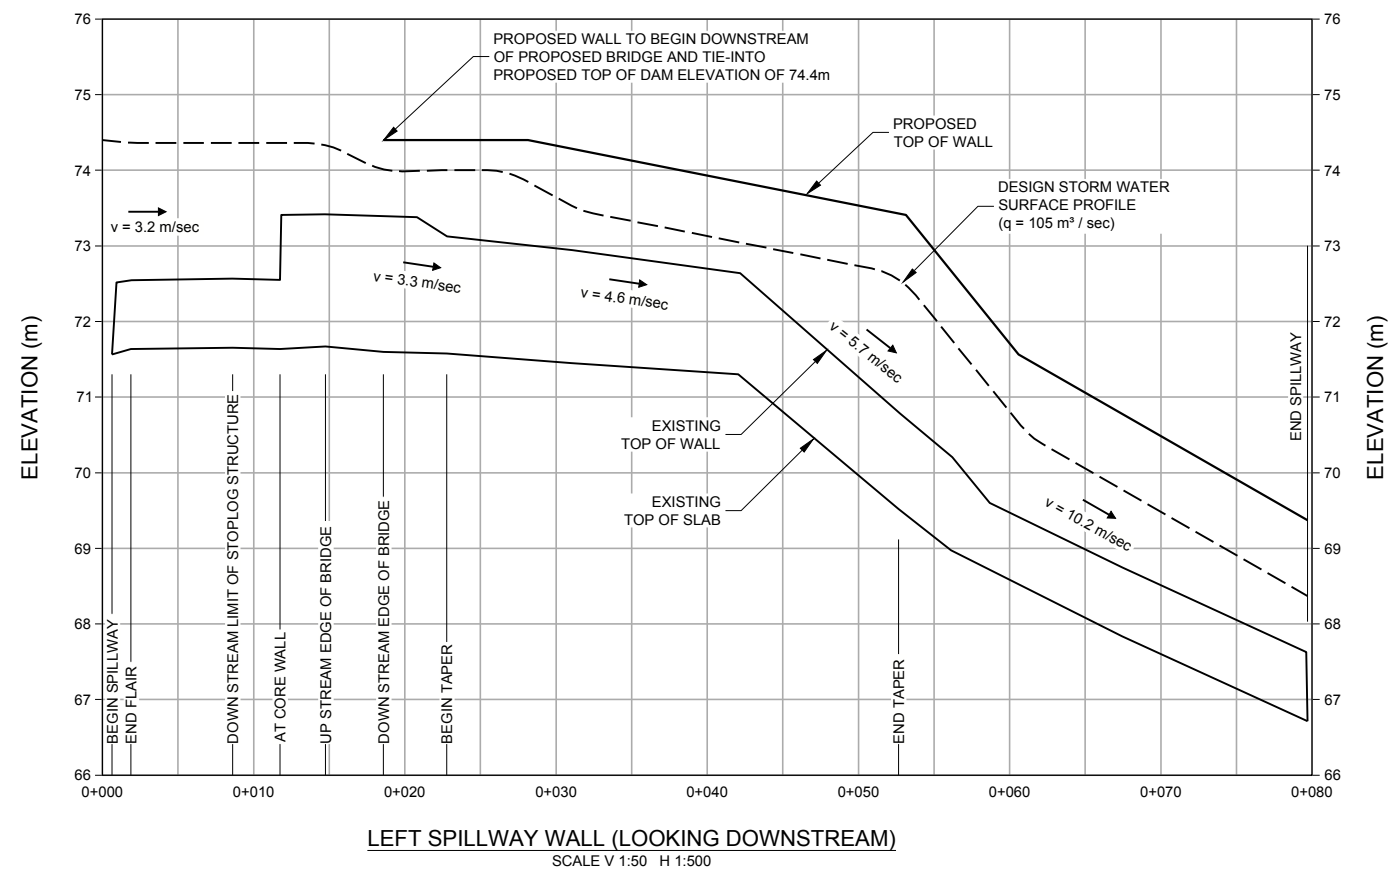
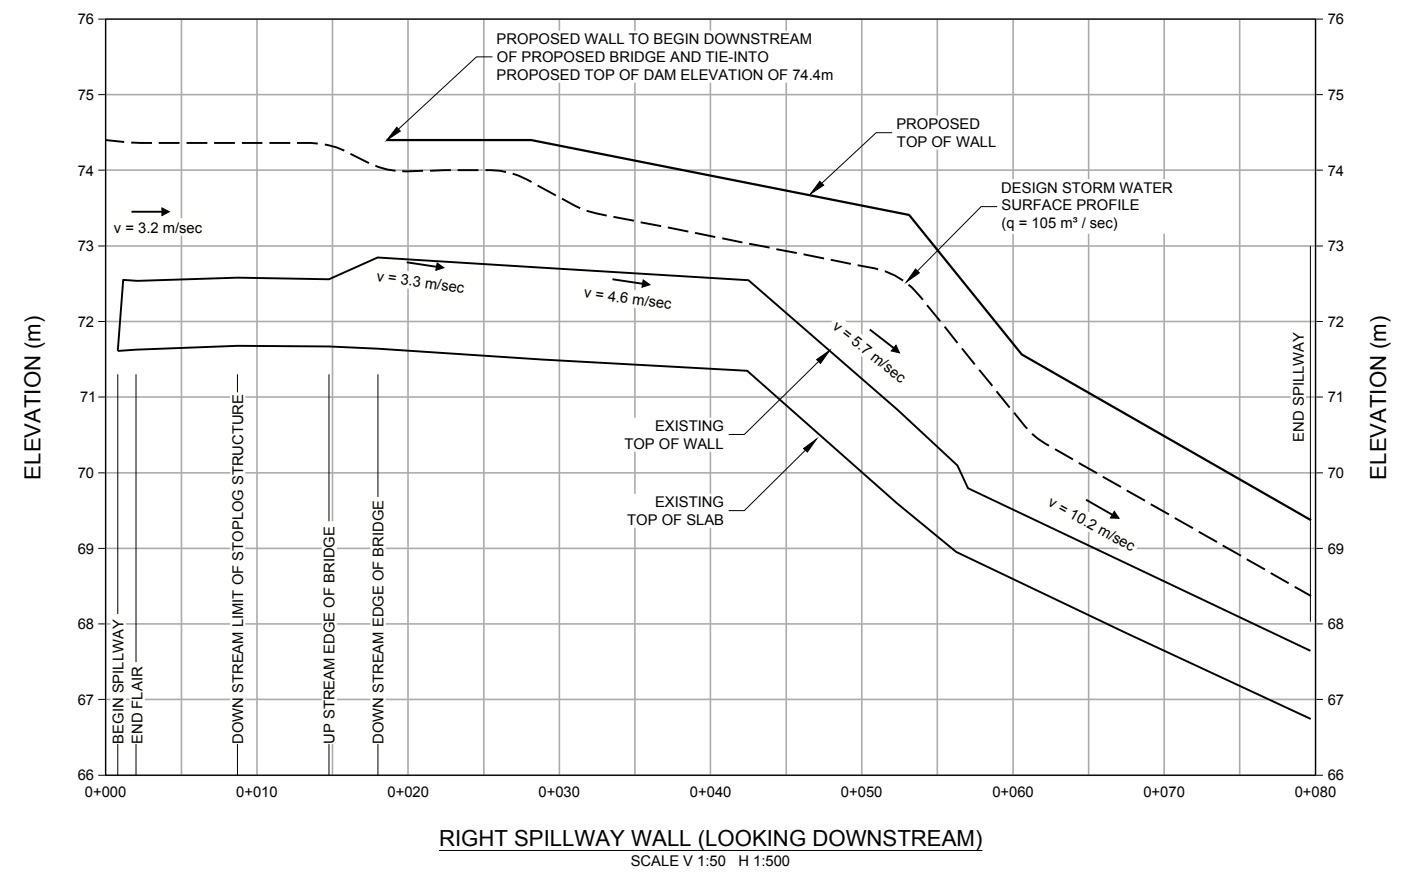
FIGURE
3

SPILLWAY PLAN
SCALE 1:250

LEFT SPILLWAY WALL (LOOKING DOWNSTREAM)
SCALE V 1:50 H 1:500

RIGHT SPILLWAY WALL (LOOKING DOWNSTREAM)
SCALE V 1:50 H 1:500

NOTE
1. PROFILES DEPICTED ARE ALONG THE STRAIGHT CENTERLINE ALIGNMENT SHOWN IN THE SPILLWAY PLAN VIEW. THE LEFT WALL'S LENGTH IS ACTUALLY LONGER DUE TO THE SPILLWAY'S TAPERING SECTION.

A profile along the spillway walls, together with the required increases to the height of the spillway walls is shown on Figure 3. The structural design for the spillway improvements were provided by Herold Engineering Ltd. (Herold). The structural drawings and corresponding letter report are shown in Appendix A.

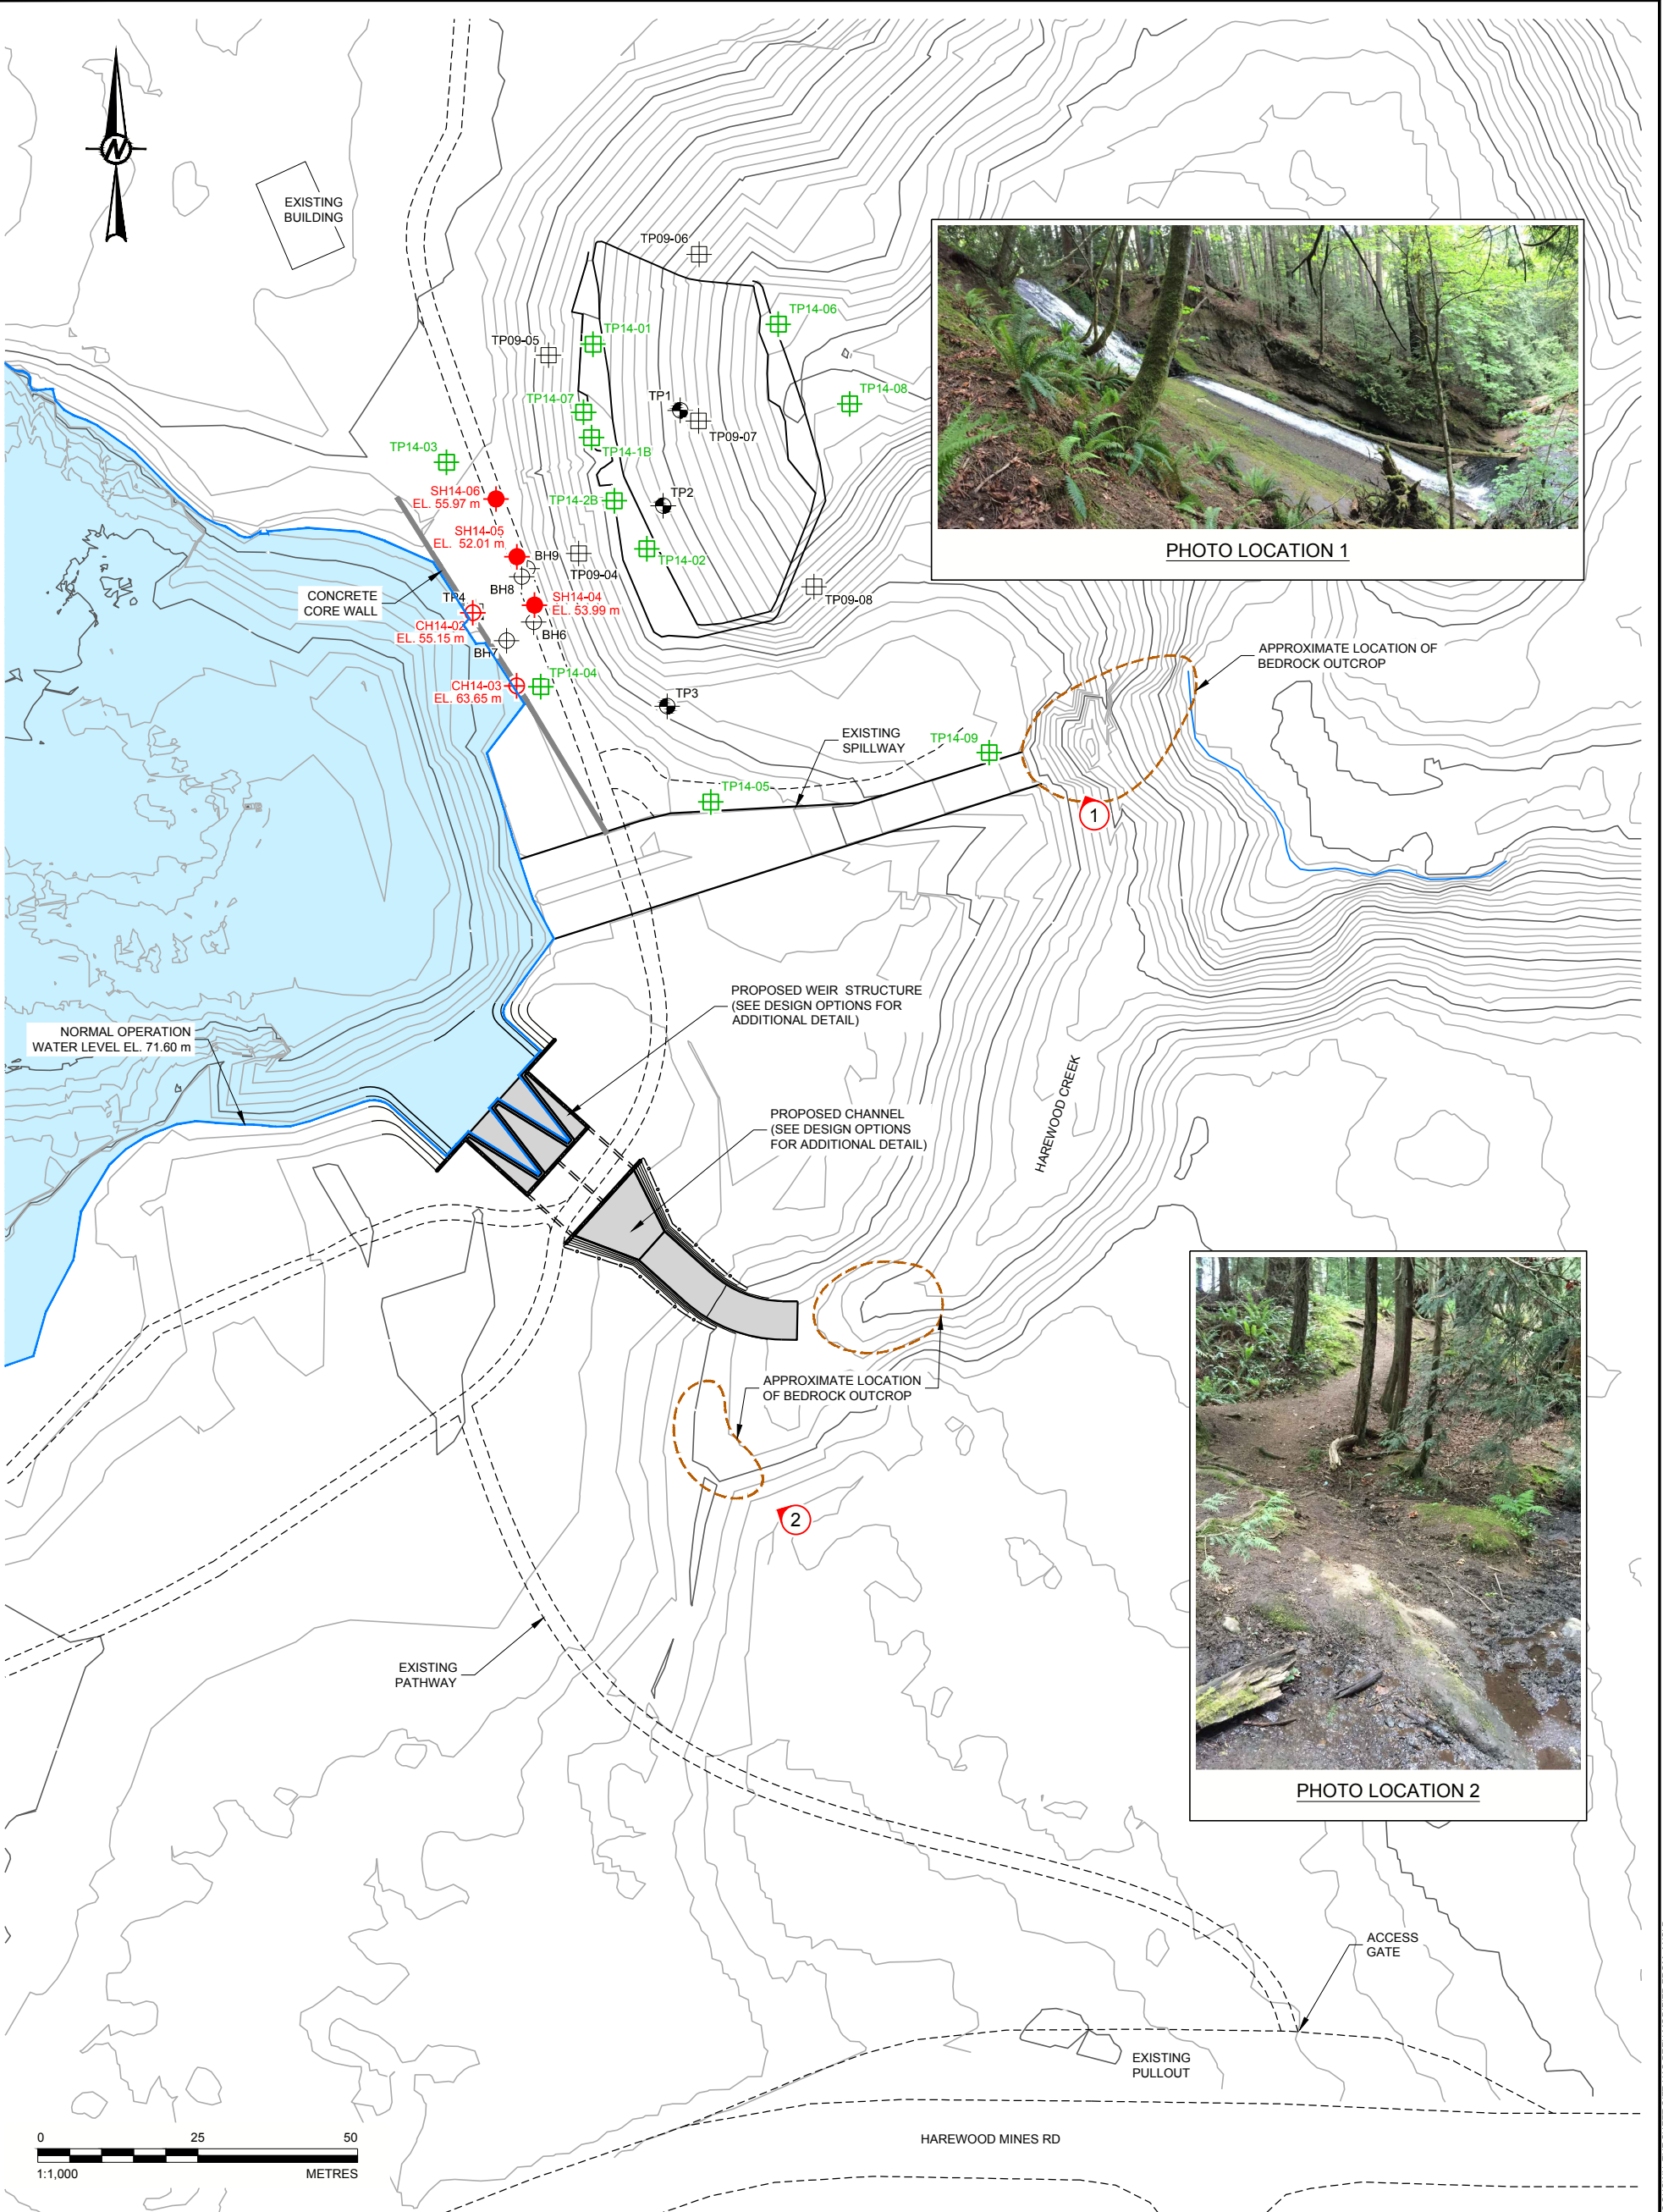
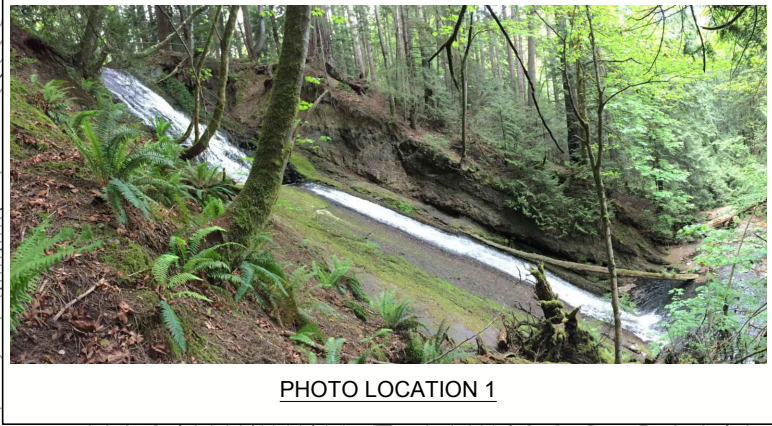
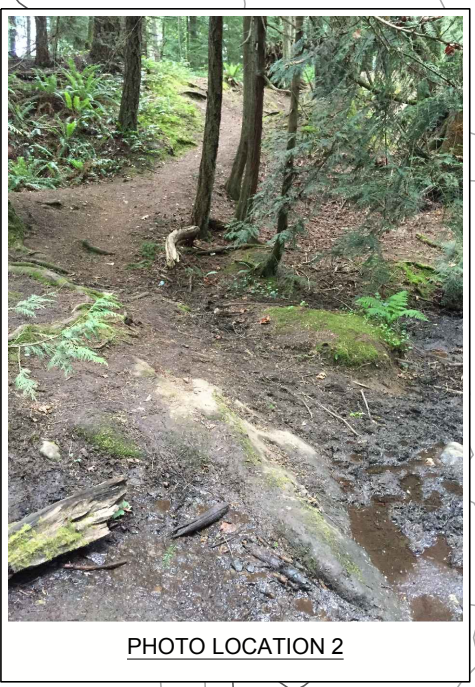
PROJECT	COLLIERY DAMS NANAIMO, BC		
TITLE	AUXILIARY SPILLYWAY AVAILABLE GEOTECHNICAL INFORMATION		
PROJECT No.	13-1447-0516	PHASE	2500
Rev.	A	FIGURE	4

- 2014 GOLDER SONIC HOLE (INCLUDING BEDROCK ELEVATION)
- 2014 GOLDER COREHOLE (INCLUDING BEDROCK ELEVATION)
- 2014 GOLDER TEST PIT (BY HAND)
- 2009 EBA TEST PIT
- 1978 GOLDER BOREHOLE
- 1978 GOLDER TEST PIT (BY EXCAVATOR)
- 1978 GOLDER TEST PIT (BY HAND)
- OUTLINE OF WALL (1.2 m THICK AT 0.6 m BELOW EXISTING GROUND)
- RESERVOIR (AT REGULAR OPERATING LEVEL)
- APPROXIMATE BEDROCK OUTCROP
- PHOTO LOCATION MARKER

- No evidence of bedrock was identified along the alignment of the proposed auxiliary spillway, although bedrock was observed at the proposed tie-in location to Harewood Creek (Figure 4).

As there is no subsurface geotechnical information along the proposed alignment of the auxiliary spillway, a review of available information was carried out in order to provide a basis for conceptual design and costing. The geotechnical understanding for the auxiliary spillway is based on observations noted during the site visit, available data from boreholes and test pits in the vicinity (approx. 50 to 120 m distant from the proposed auxiliary spillway location, as shown on Figure 4) and regional geology information (BC MEM 1998), as shown on Figure 5.

- **Subsurface information from nearby boreholes** (see Figure 4)—Bedrock was encountered in all boreholes drilled in 2014 and generally comprises massive, dark grey to grey, medium strong, clast supported conglomerate.

The borehole and test pit locations from previous investigations carried out by Golder and others at the Lower Dam are shown in Figure 4. A review of this information shows that glacial till generally overlies bedrock in the area.

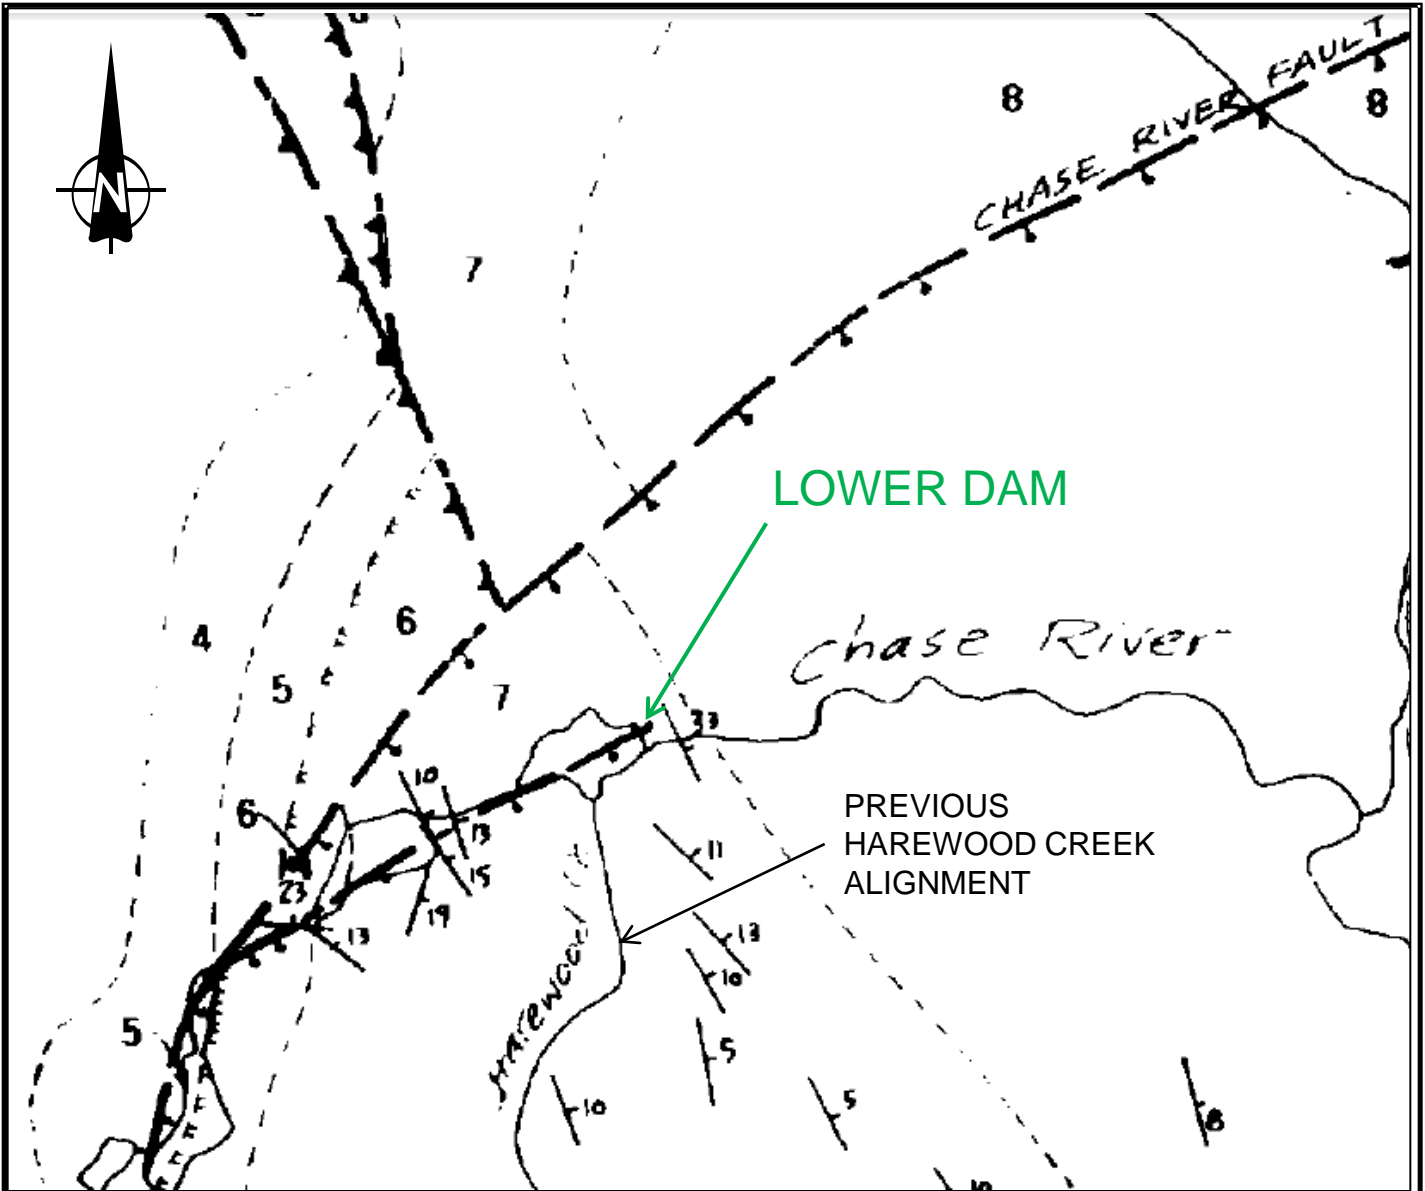
PROJECT		COLLIERY DAMS NANAIMO, B.C.		
TITLE				
SITE GEOLOGY				
PROJECT No. 13-1447-0516		PHASE No. 3000		
DESIGN	JKG	19Jun15	SCALE	NTS
CADD	----	19 JUN15	REV.	
CHECK	JKG	19Jun15	FIGURE 5	
REVIEW	BD	03 July 15

UPPER CRETACEOUS – NANAIMO GROUP

- **Regional surficial bedrock geological mapping**—Based on available geological maps (BC MEM 1998), the Lower Dam and auxiliary spillway are located within the Upper Cretaceous, Millstream Member of the Nanaimo Group, as shown on Figure 5. The Millstream Member comprises conglomerate and gritstone, minor sandstone, siltstone and carbonaceous shale and coal. The bedding in the area dips to the northeast. A normal fault dipping to the southeast is shown running through the Lower dam where it appears to terminate on the downstream side. The Chase River Fault (a normal fault) runs northeast – southwest and is approximately 400 m north of the dam. A geological boundary is shown approximately 100 m to the east of the dam, striking northwest – southeast.

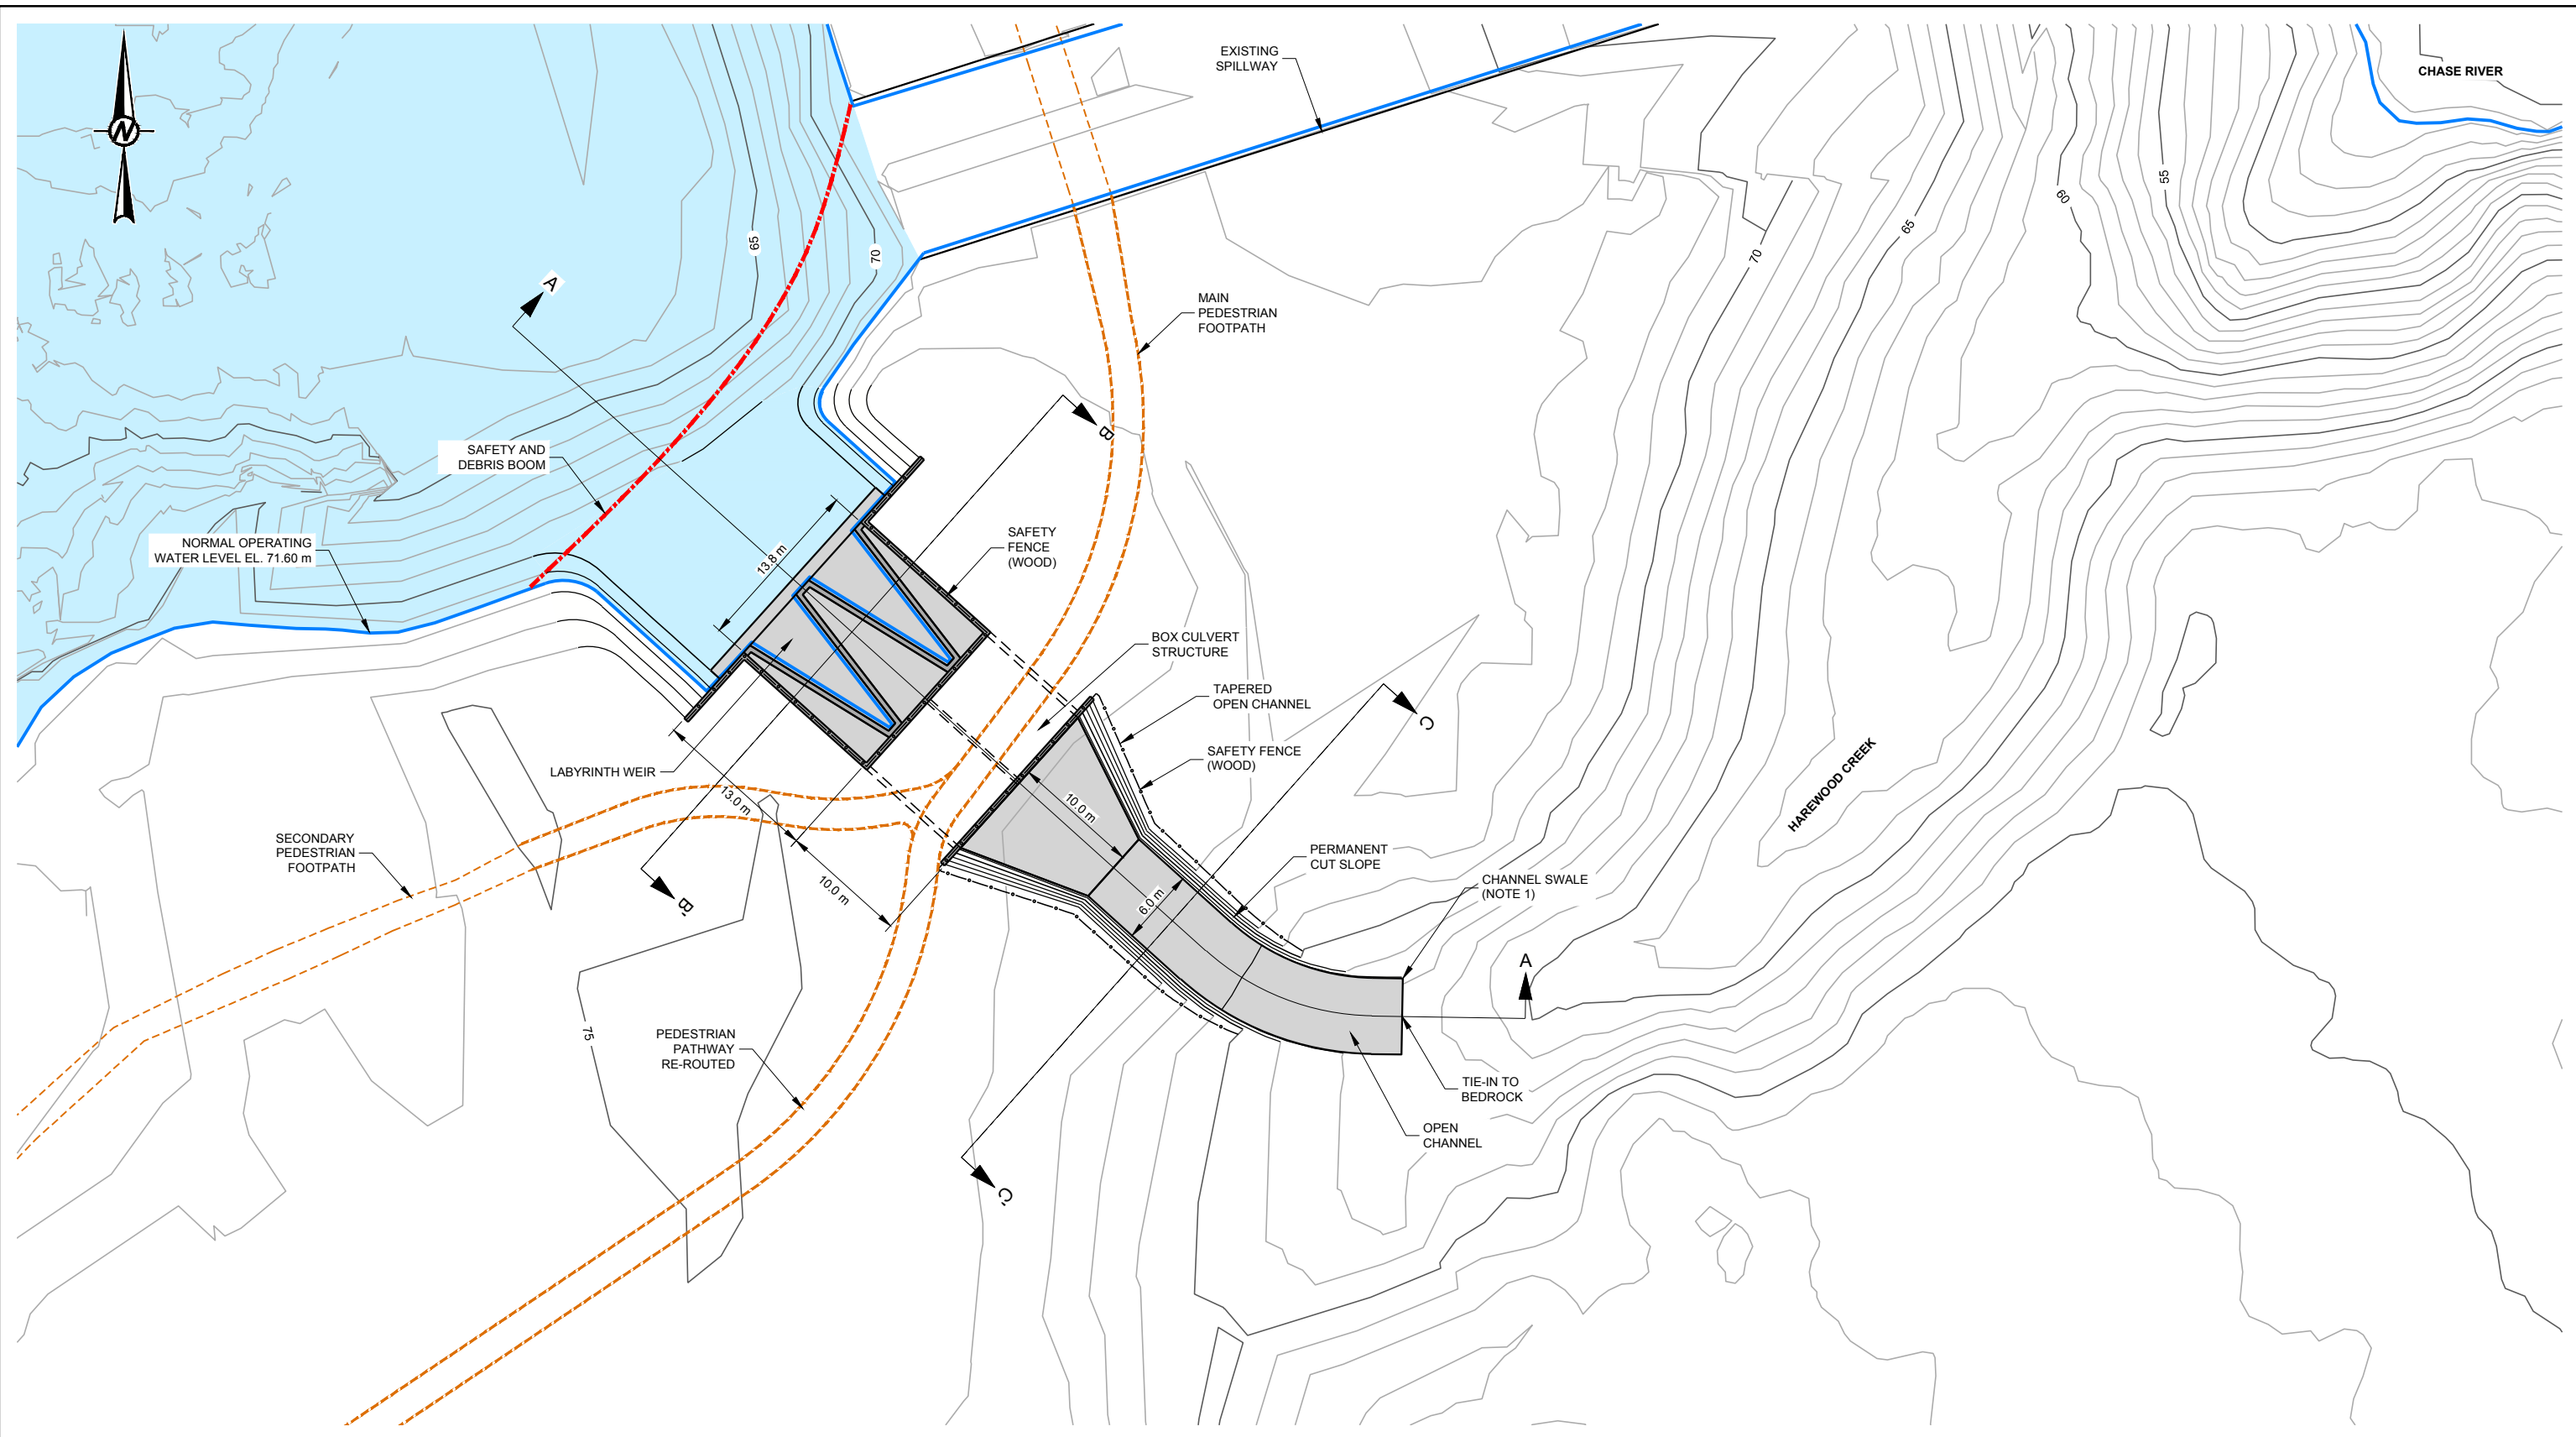
1. DOWNSTREAM OF THIS POINT, CHANNEL SWALE TO BE TIED INTO EXISTING TOPOGRAPHY OF HAREWOOD CREEK.
2. FINAL CONFIGURATION SHOWN - CONSTRUCTION REQUIREMENTS NOT REPRESENTED ON THIS FIGURE.
